AIRFIELD PAVEMENT MANAGEMENT REPORT MARYSVILLE MUNICIPAL AIRPORT

Prepared for the
KANSAS DEPARTMENT OF TRANSPORTATION
Topeka, KS

December 2014

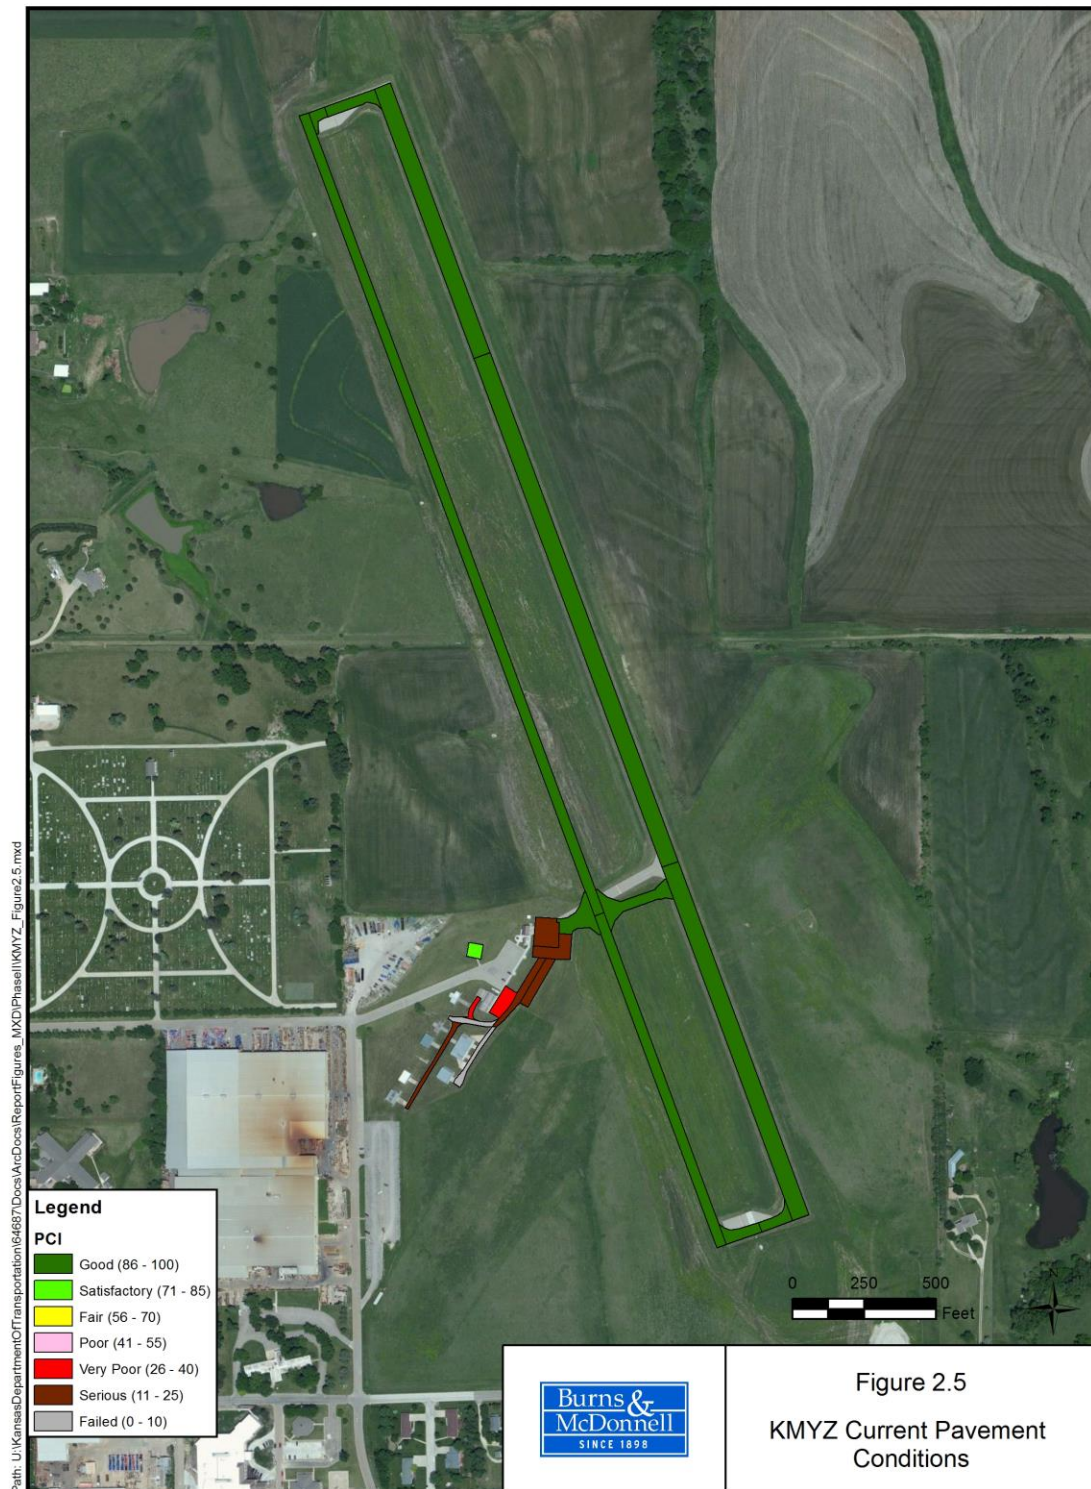
An aerial photo with the pavement condition of each pavement section is provided in Figure 2.5, and the breakdown of each branch's weighted PCI is identified in Table 2.1.

Branch ID	Usage	Weighted Average PCI
AA	Apron	20
AB	Apron	25
AC	Apron	30
H1	Helipad	85
R16	Runway 16-34	91
TA	Taxiway A	98
TA1	Connecting Taxiway	95
TA2	Connecting Taxiway	97
TA3	Connecting Taxiway	94
TA4	Connecting Taxiway	97
TL1	Taxilane	13

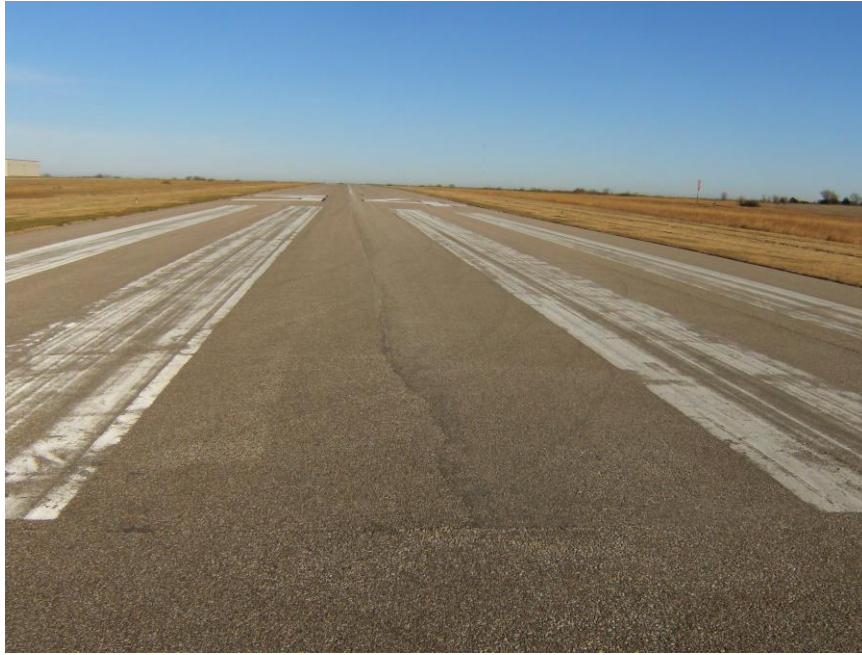
Figure 2.6: Condition of Runway 16-34

Runway 16-34 currently features an asphalt concrete pavement structure. The pavement section consists of approximately 6-inches of asphalt concrete on 6-inches of crushed aggregate base on 9-inches of fly-ash treated subgrade. In 2004, the runway received a 3-inch asphalt overlay. A photo of Runway 16-34 and its condition at the time of inspection is illustrated in Figure 2.6.

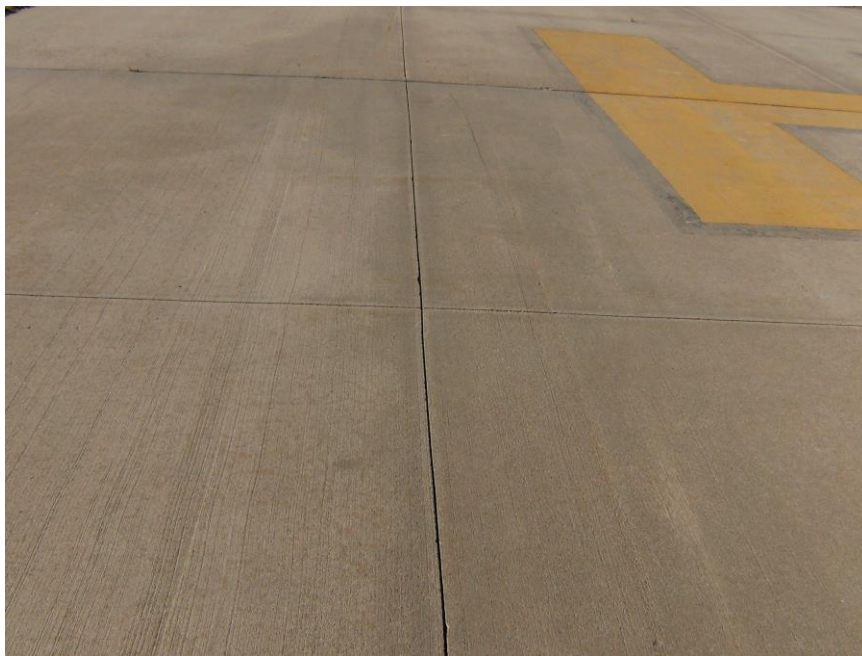
Figure 2.7: Condition of Helipad 1

Helipad 1 currently features a Portland cement concrete pavement structure. It should be noted that Helipad 1 did not have construction history available; therefore, the MicroPAVER program was used to calculate the last estimated construction date. If future information becomes available, the MicroPAVER database should be updated. A photo of Helipad 1 and its condition at the time of inspection is illustrated in Figure 2.7.

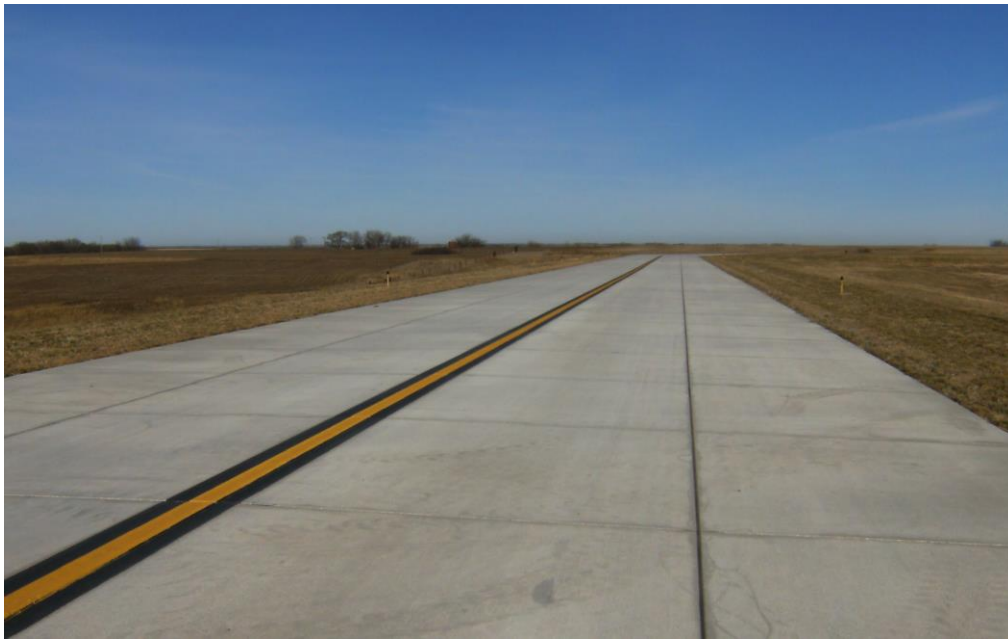
Figure 2.8: Condition of Taxiway A

Taxiway A consists of a new Portland cement concrete pavement structure constructed in 2011. Taxiway A is a full length taxiway parallel to Runway 16-34. The new pavement section consists of 6-inches of Portland cement concrete on 4-inches of aggregate base on 8-inches of cement kiln dust treated subgrade. A photo of Taxiway A and its condition at the time of inspection is shown in Figure 2.8.

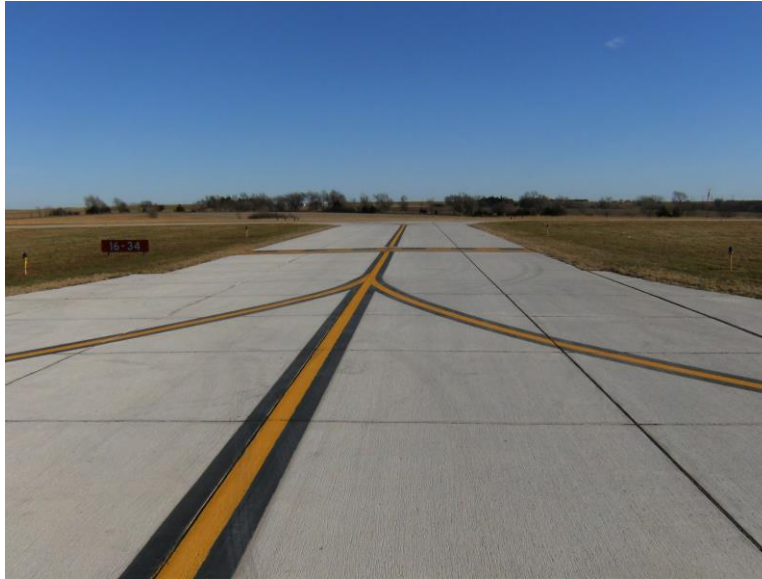
Figure 2.9: Fully Reconstructed Connecting Taxiway A-1

These branches include the Connecting Taxiways A1, A2, A3, and A4. Connectors A1 and A2 were reconstructed in 2011 with 6-inches of Portland cement concrete on 4-inches of aggregate base on 8-inches of cement kiln dust treated subgrade. Connectors A3 and A4 were partially reconstructed in 2011. The remaining pavement consists of an asphalt concrete surface which was overlain with 3 inches of asphalt in 2004. The reconstructed section consists of 6-inches of Portland cement concrete on 4-inches of aggregate base on 8-inches of cement kiln dust treated subgrade. A typical photo of the fully reconstructed connector taxiways is shown in Figure 2.9 and a typical photo of the partially reconstructed connector taxiways is given in Figure 2.10.

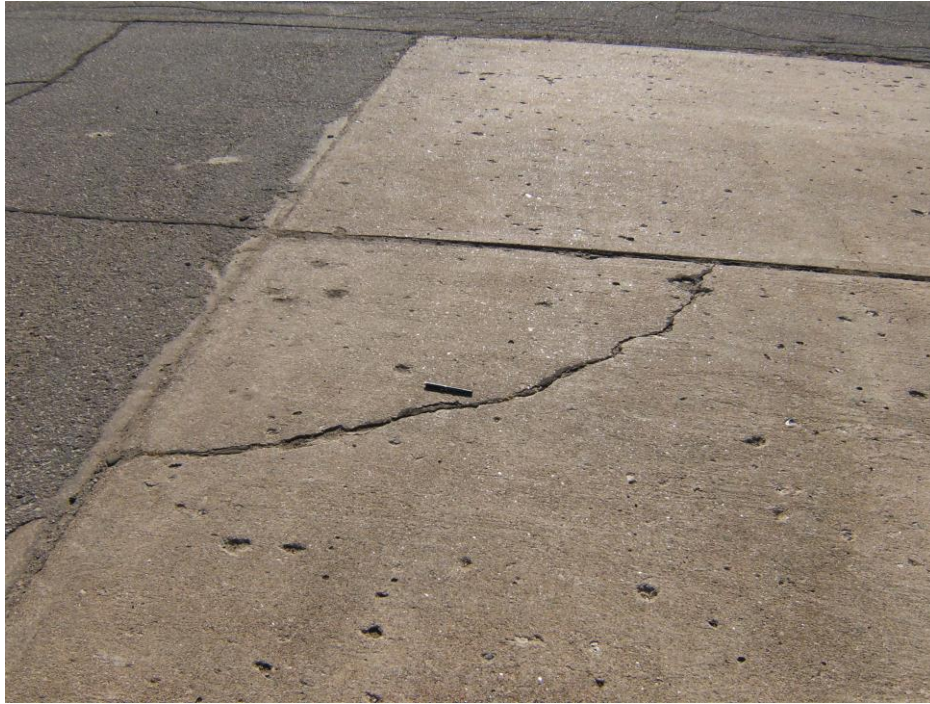
The general aviation apron consists of a section with an asphalt concrete surface and a section with a Portland cement concrete surface. The aircraft parking apron consists of a Portland cement concrete pavement section. It should be noted that the apron areas did not have construction history available; therefore, the MicroPAVER program was used to calculate the last estimated construction date. If future information becomes available, the MicroPAVER database should be updated. A photo of the typical distresses on the general aviation apron is shown in Figure 2.11 and a photo of aircraft parking apron is given in Figure 2.12.

Figure 2.11: Corner Break and Popouts on the General Aviation Apron

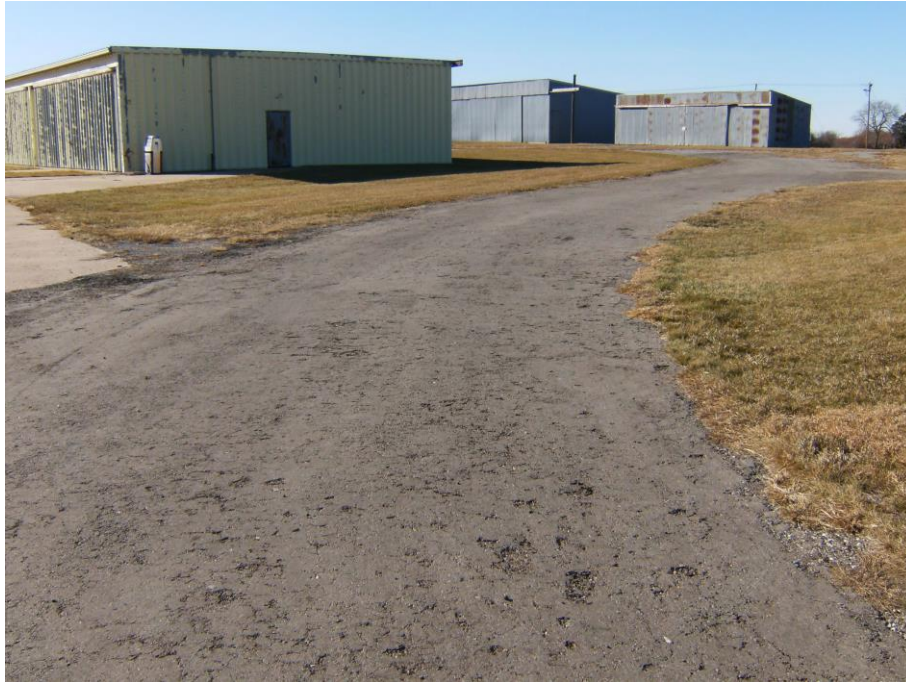
The taxilanes consist of a section with a Portland cement concrete surface and sections with asphalt concrete surfaces. It should be noted that the taxilanes did not have construction history available; therefore, the MicroPAVER program was used to calculate the last estimated construction date. If future information becomes available, the MicroPAVER database should be updated. A photo of a typical taxilane and its condition at the time of inspection is shown in Figure 2.13.

Figure 2.13: Raveling on Taxilanes
