AIRFIELD PAVEMENT MANAGEMENT REPORT MARYSVILLE MUNICIPAL AIRPORT

Prepared for the
KANSAS DEPARTMENT OF TRANSPORTATION
Topeka, KS

December 2014

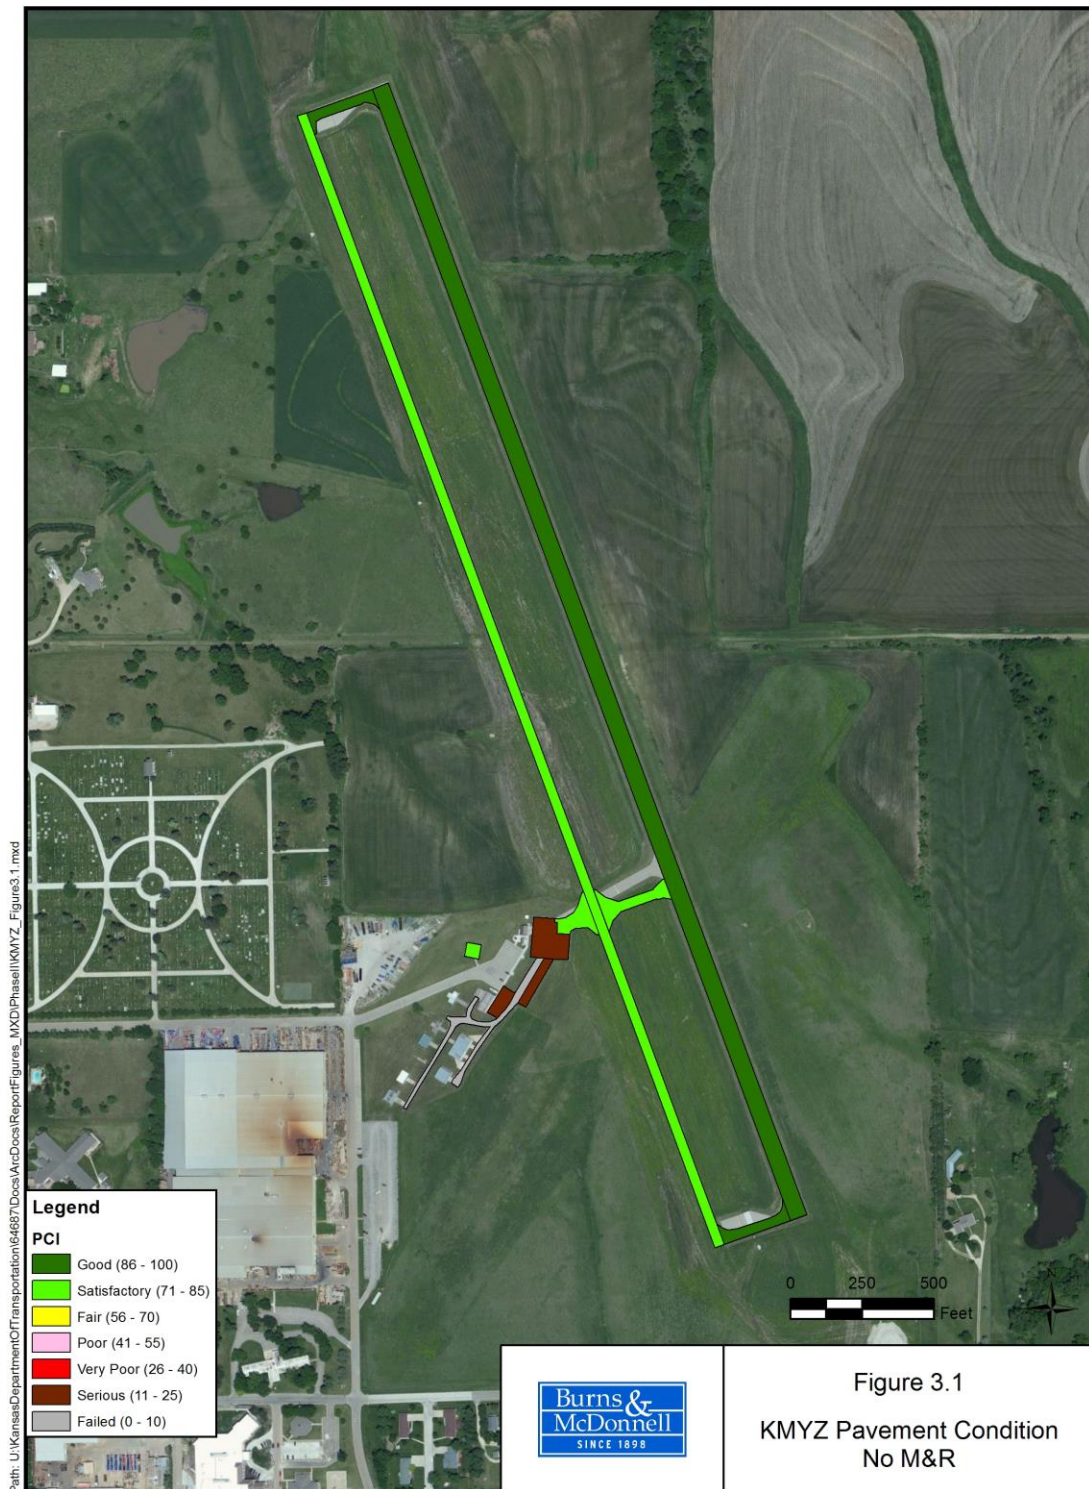
The first scenario examined for Marysville Municipal Airport involves predicting the resultant PCI values of those pavement sections inspected if no maintenance or rehabilitation is performed over the next 5-year period. A figurative representation of the condition presented in the year 2017 is included in Figure 3.1. As the figure displays, a significant drop off in pavement condition is anticipated when no maintenance or rehabilitation is performed. Table 3.1 provides a yearly examination of each branch's PCI value if no maintenance work is performed.

Branch ID	2013	2014	2015	2016	2017
AA	19	17	15	13	11
AB	24	23	21	19	17
AC	29	28	26	24	23
H1	85	85	84	84	83
R16	90	89	88	87	86
TA	96	93	90	87	84
TA1	94	91	88	85	82
TA2	96	93	90	87	84
TA3	93	92	90	89	87
TA4	95	93	92	90	88
TL1	12	10	9	7	6

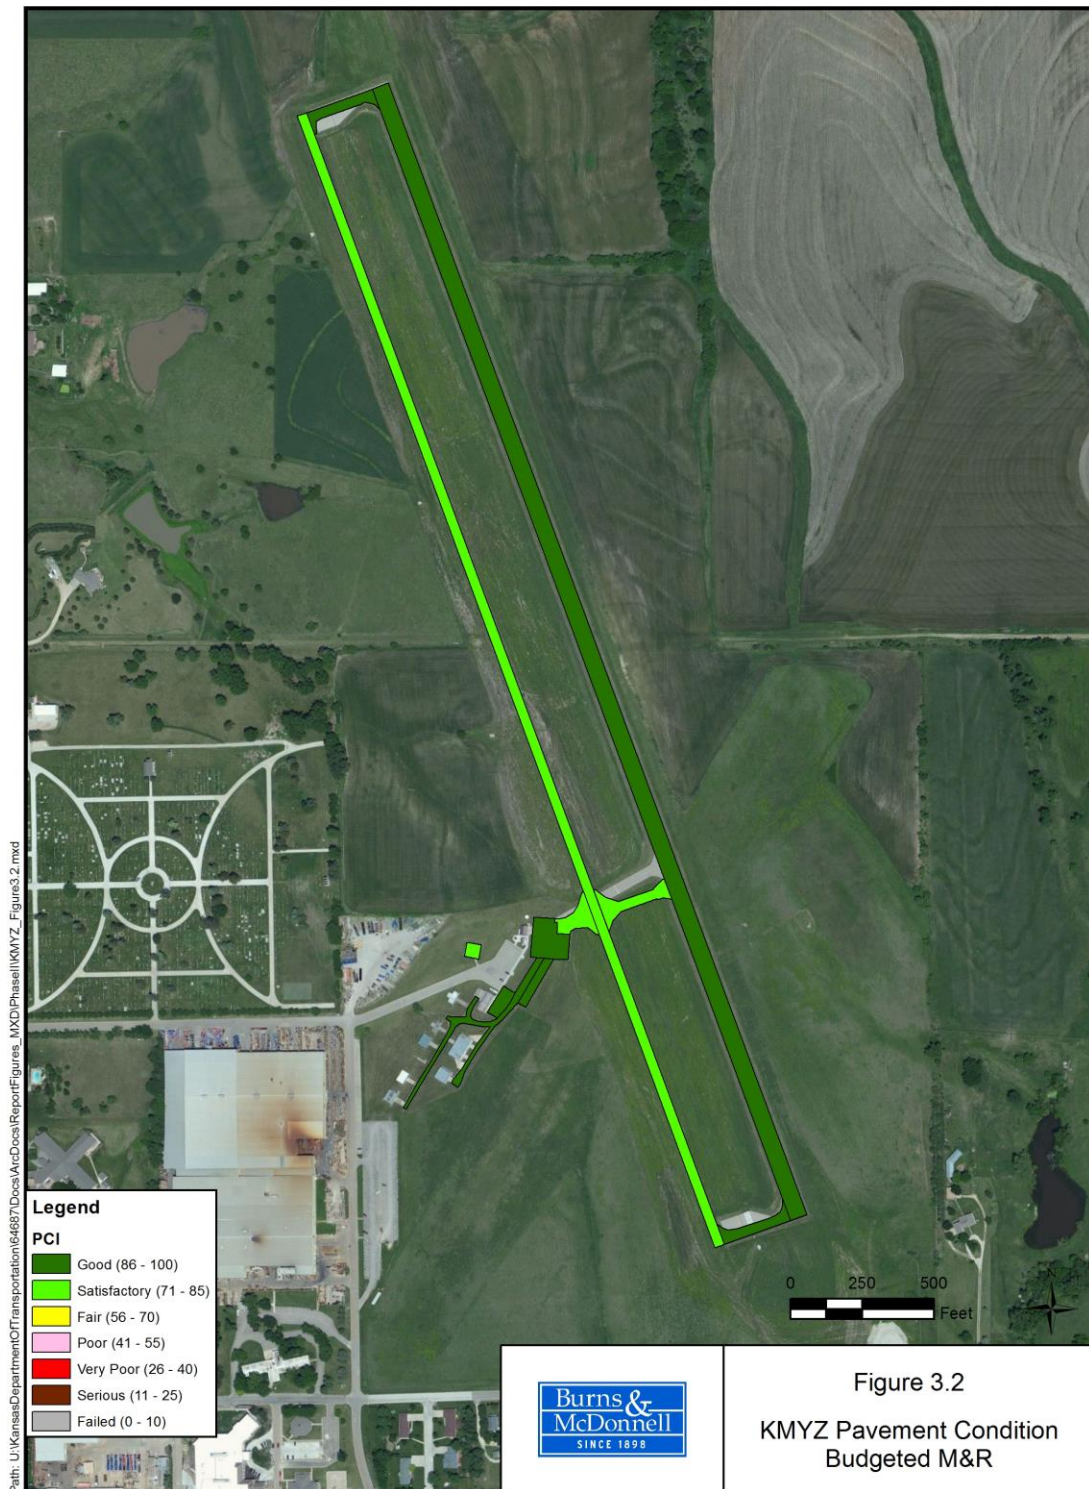
Regarding limited budget maintenance; a number of items of note can be taken from this analysis. Please also note the reconstruction of Apron AA, AB, and AC in the first few years. This will require considerable funds to increase the PCI value.
